PROPERTY INSPECTION REPORT

Concerning: 3808 Doris, Amarillo, Tx
(Address or Other Identification of Inspected Property)

By: Curt Johnston #10188 10/07/11
(Name and License Number of Inspector) (Date)

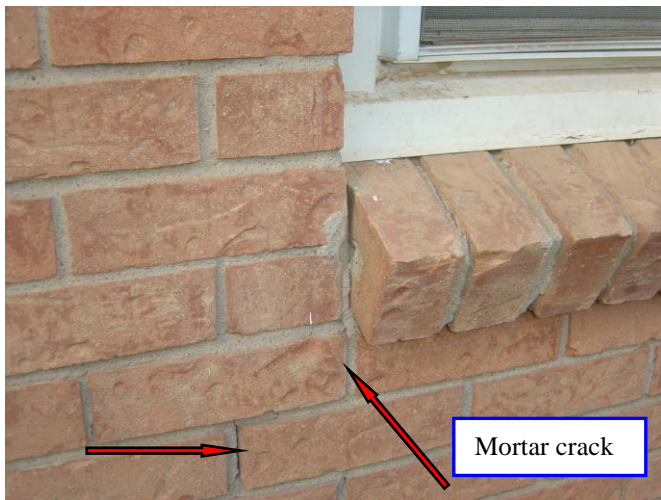
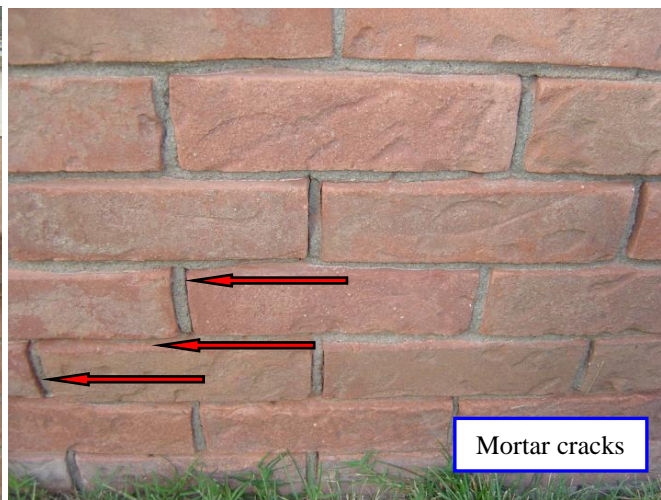
- Common minor cracks were observed in the foundation walls of the house at the south east corner of the house. This implies that some structural movement of the building has occurred, as is typical of most houses. The crack should be sealed and monitored.
- Cracks were observed on the exterior walls of the house along the east side of the house. This implies that some structural movement of the building has occurred, as is typical of most houses. Mortar cracks should be sealed and monitored.
- The sidewalk on the west side of the home has pulled away from the foundation. The crack should be sealed between the sidewalk and the foundation.
- The soil has pulled away from the back (south) wall. Dry soil.

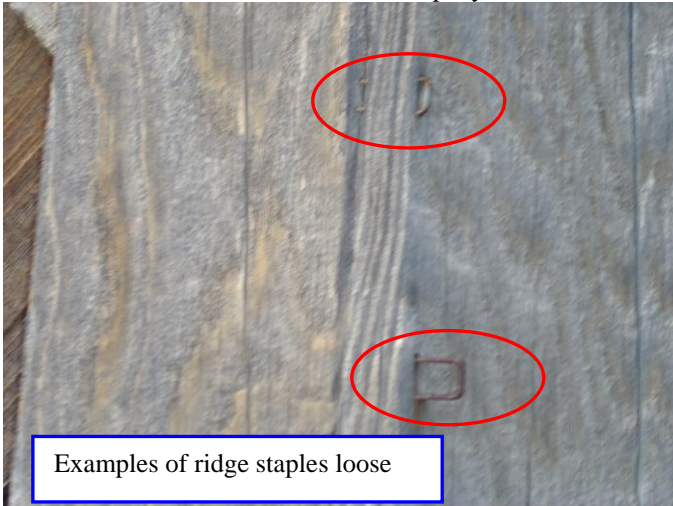
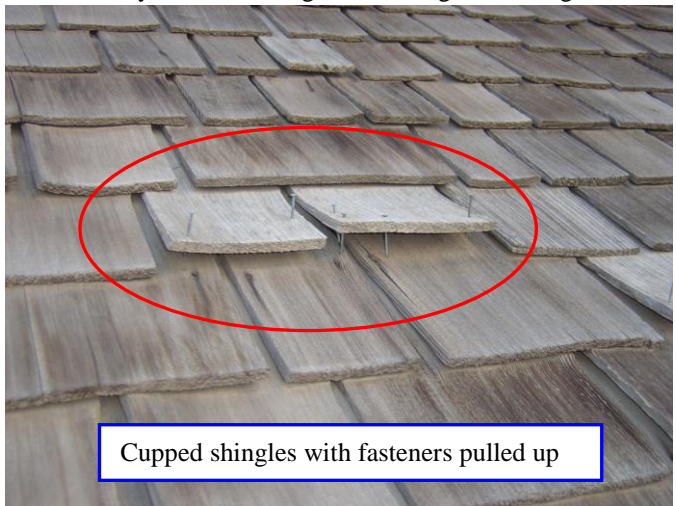
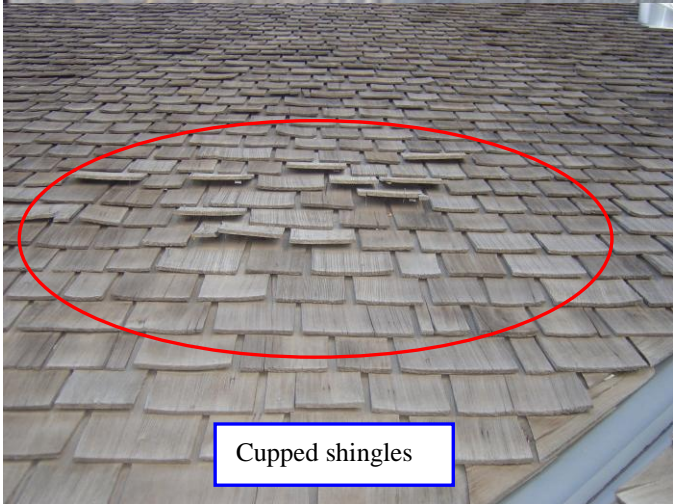
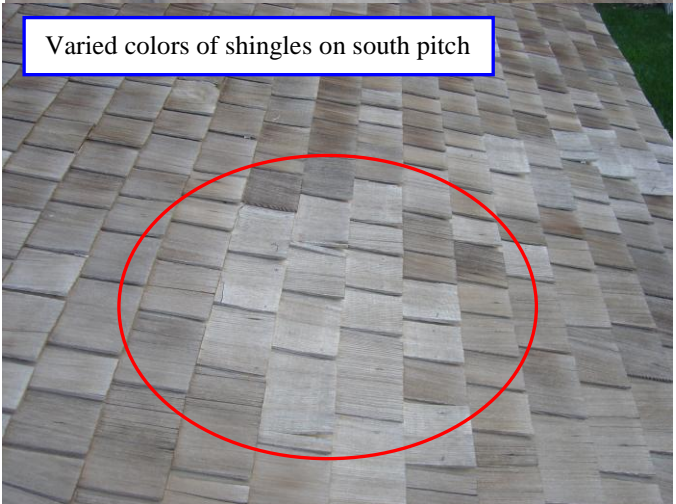
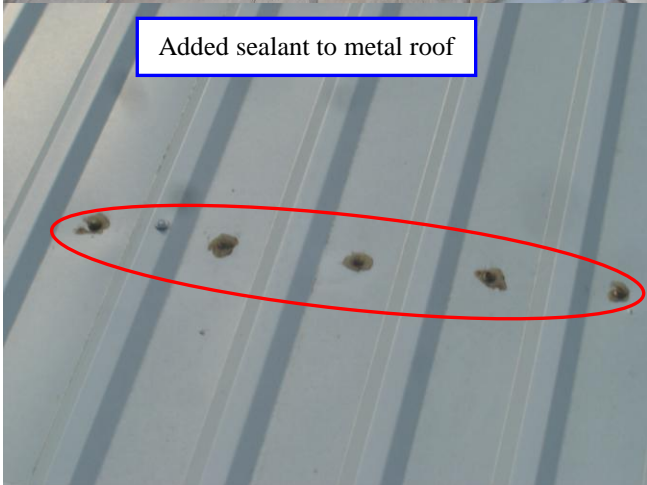
- There are some loose fasteners in various locations of the roof; the ridge and the south pitch near the chimney are 2 examples.
- There are some areas that are discolored which could have been a patched area?
- There are some areas where the shingles have “cupped” and extra nails have been added and some nails have pulled loose. The weather has been extremely dry this year.
- The metal porch roof is metal. Some screws have added sealant over them and should be monitored. The metal roof was not walked.

➤ THIS IS NOT AN INSURANCE INSPECTION. It is recommended to have your insurance company evaluate the roof for insurability. Wood roofing is becoming harder to get insured.

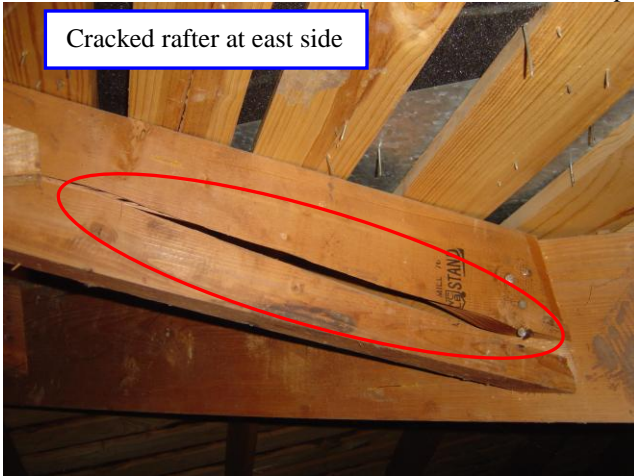
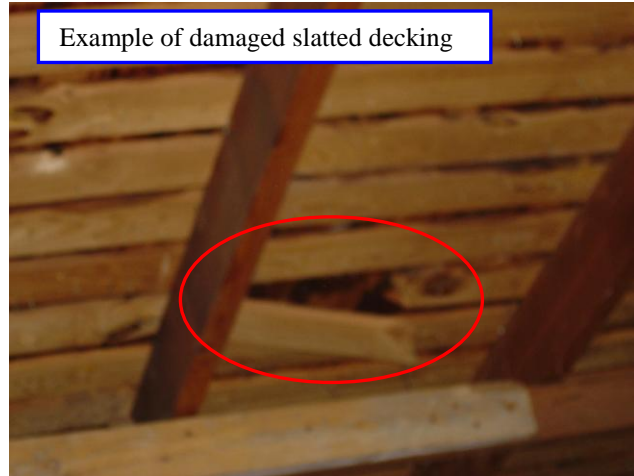
- There is a slatted roof for the wood shingles. There are some moisture stains in various locations of the roof.
- The skylight attic wall insulation is loose and needs to be re-secured.
- There are some broken slats at the roof that will need to be repaired. There is an example on the east and south pitch areas. The broken ones should be repaired.
- The ridge board is a 1X instead of a 2X which is the standard today.
- There is a cracked ridge board on the attic to the west near the chimney. The board should be repaired.

- All mortar and concrete cracks and low mortar areas should be re-pointed and or sealed.
- The attic cracked rafter and broken decking should be repaired.
- The chimney cap should be repaired.
- The water heater T&P valve should be moved or improved.

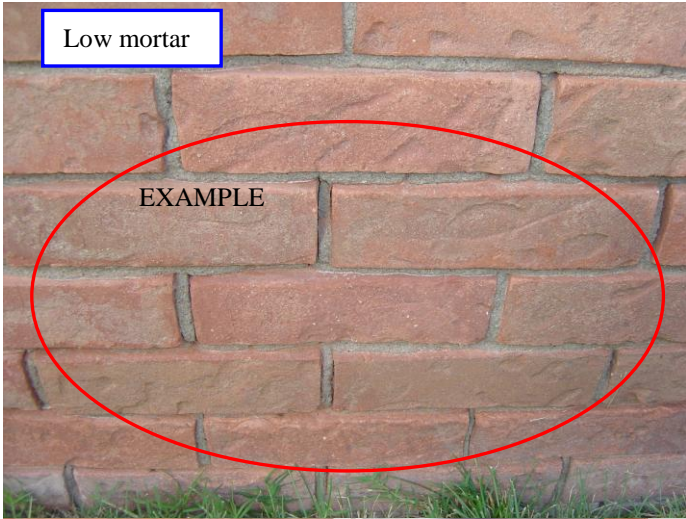
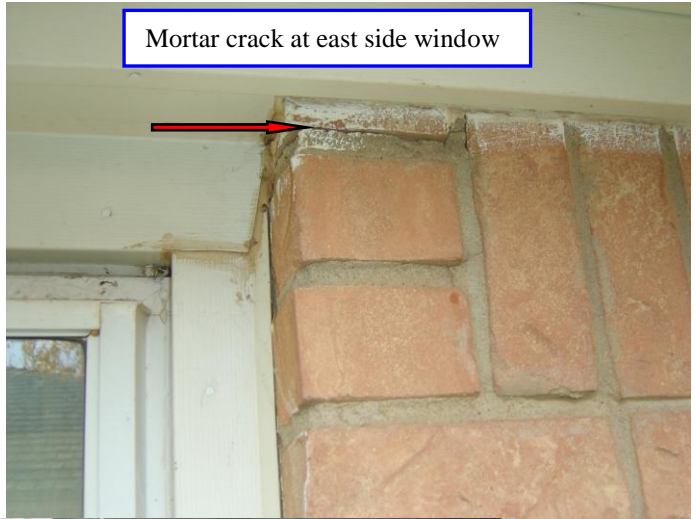
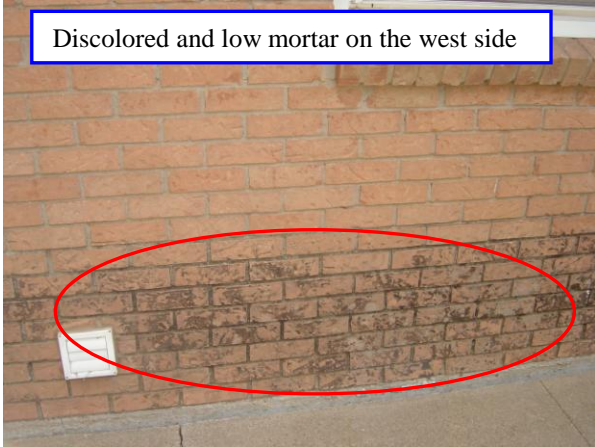
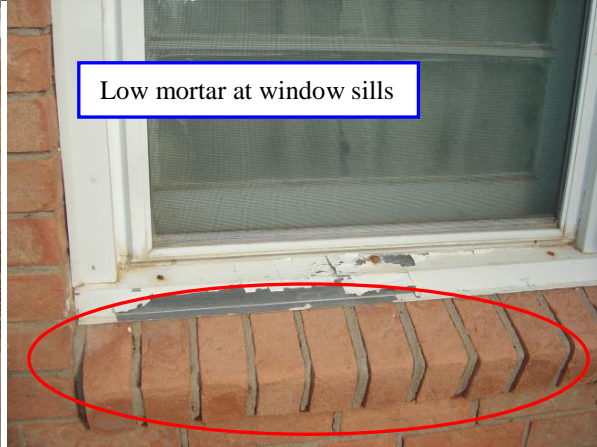
- *There is an interior crack in the southeast bathroom above the door.*
- *There is a movement crack in the northeast bedroom at the closet door; the inside of the closet and the outside both have cracked. The cracks should be sealed and monitored.*
- *The tile areas of the home should be monitored for sealing needs.*

- *There are low mortar areas of the brick wall (exterior) that will need re-pointing.*
- *There are various locations where mortar has cracked and will need repair. There is an example just east of the front door to the east and another on the east side of the home and the middle window up at the top of the window. (horizontal bricks of the window trim)*
- *There is exterior wood trim and doors and windows that need painting and sealing.*

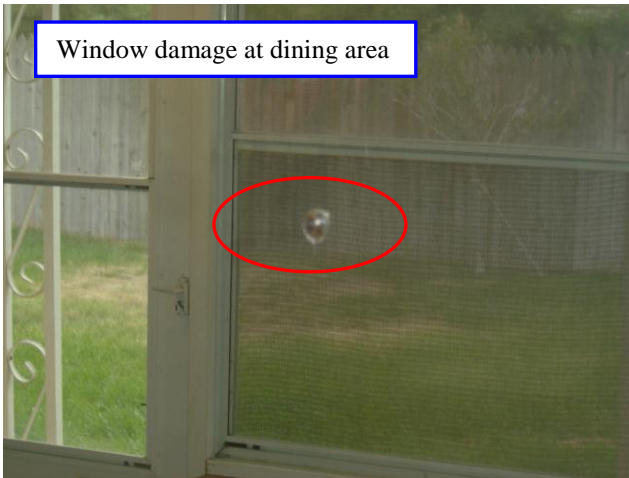
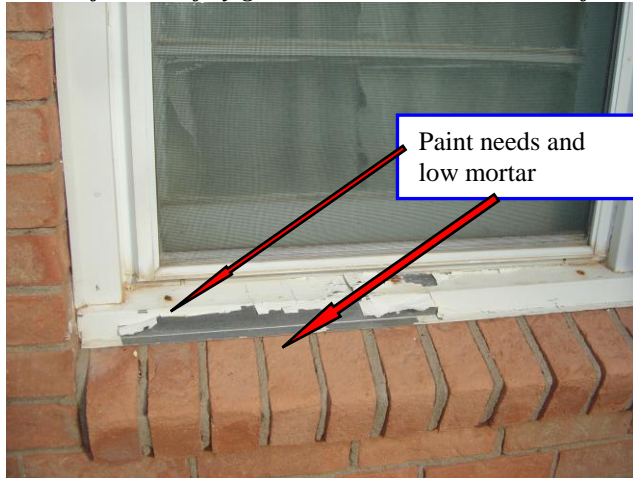
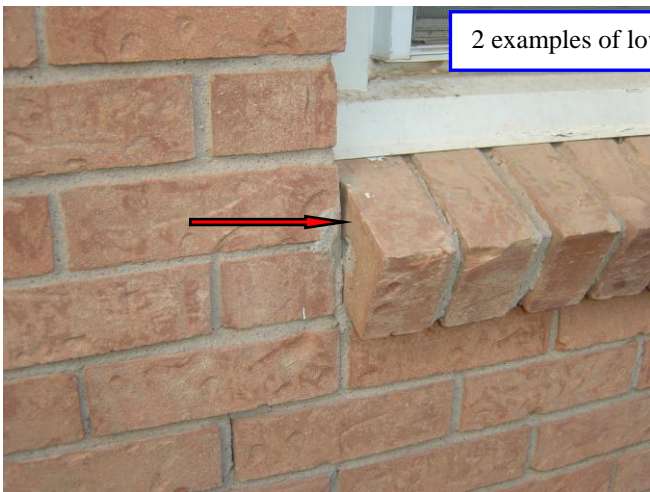
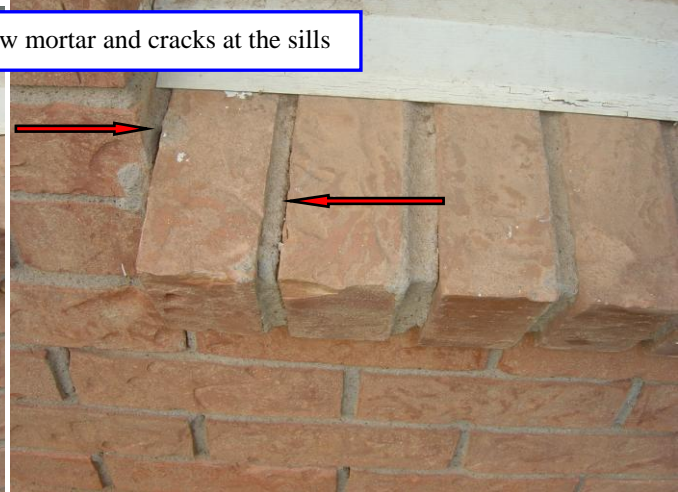
- *The brick sills (exterior) will need mortar repair (re-pointing) in various locations. The east middle window is 1 example.*
- *The 2 southeast windows are in need of painting.*
- *The sleeping rooms should have operating windows for “fire escape”. The east side and the south side sleeping rooms do not have operating windows (with normal force) and are in need of repair.*
- *Most of the windows (interior) are hard to open. Cleaning and lube is necessary; then check for proper operation.*
- *The large window in the dining area has damage (“bullet dents”) the window in not verified as safety glass and should be monitored for cracking.*

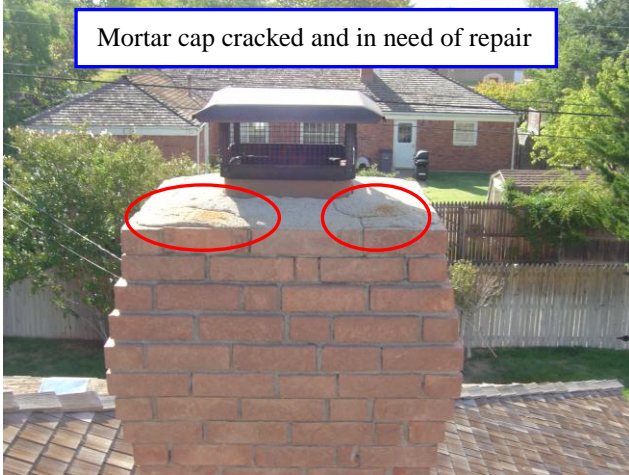
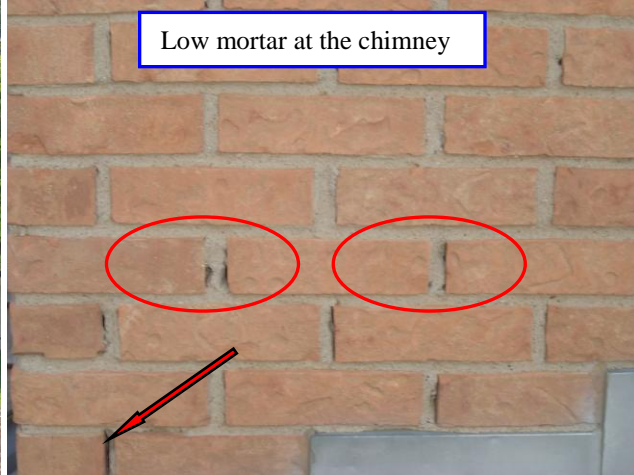
- *The mortar cap is in need of repair.*
- *There are low mortar areas on the chimney.*
- *There is smoke residue on the front of the fireplace. The fireplace has a gas log set up in place; if a regular fire place (for wood burning) is to be used the “draw” should be evaluated.*

- *With a gas log set up in place a damper block should be installed. The gas flex-line was not accessible to verify its type or condition and should be closely evaluated before use.*

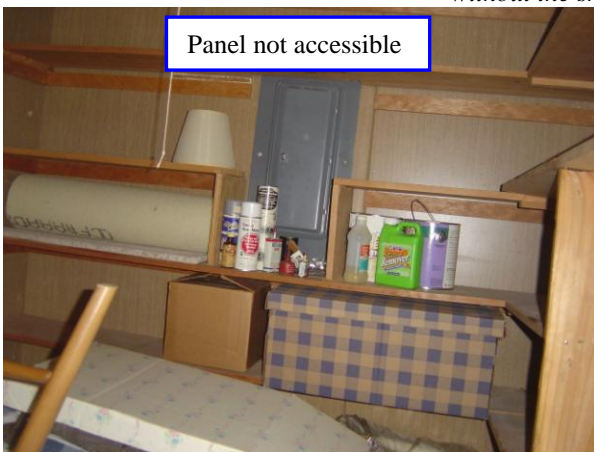
- ❖ *The panel was in a closet full of garage sale items and was not accessible for inspection. There is a shelf visible from the door that does not allow the panels cover to be removed without the shelf being removed. Improper service clearance.*

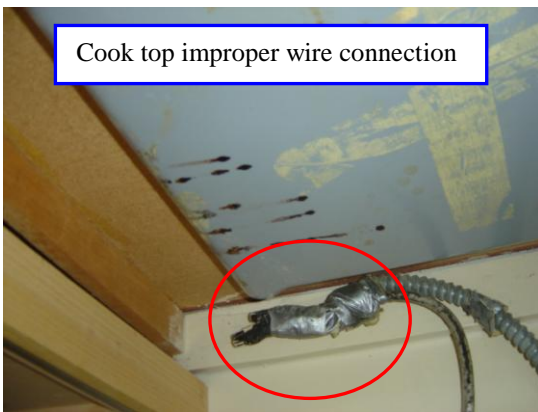
- *There are not GFCI outlets in the kitchen, bathrooms, garage and at the exterior as recommended by today's standards. There is only one in the southeast bathroom.*
- *There is an electrical box mounted at the front porch area (east) that is not an exterior rated box. The outlet box should be replaced with a proper exterior box.*

- *The kitchen light over the sink did not come on at the wall switch.*
- *There is an improper wire splice to the cook top (not in a junction box with a cover). A proper box and cover should be installed for the connection.*
- *There are grounded outlets on an ungrounded system in various locations of the home. There are several 2 wire outlets in place in the home. The 3 wire outlets (3 prong outlets) are not grounded.*
- *There is a switch in the entry area and one in the back bathroom that were not verified for what they operate.*
- *There are exposed light bulbs in the closets. By today's standards they would have globes installed for fire protection.*
- *There is a broken cover plate in the east middle bedroom on the north wall.*

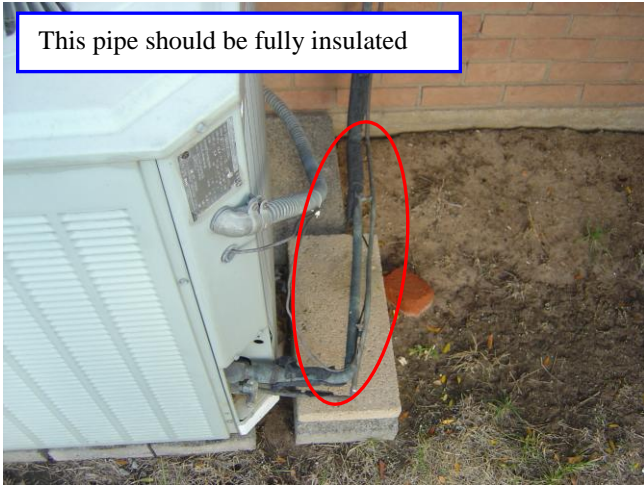
- *There is a condensate pump in place that will require maintenance per the manufactures label. The unit's termination was not verified.*
- *The insulation of the large copper line to the exterior unit should be fully insulated; AND IS IN NEED OF IMPROVEMENT.*

- The insulation to the condenser unit should be improved.

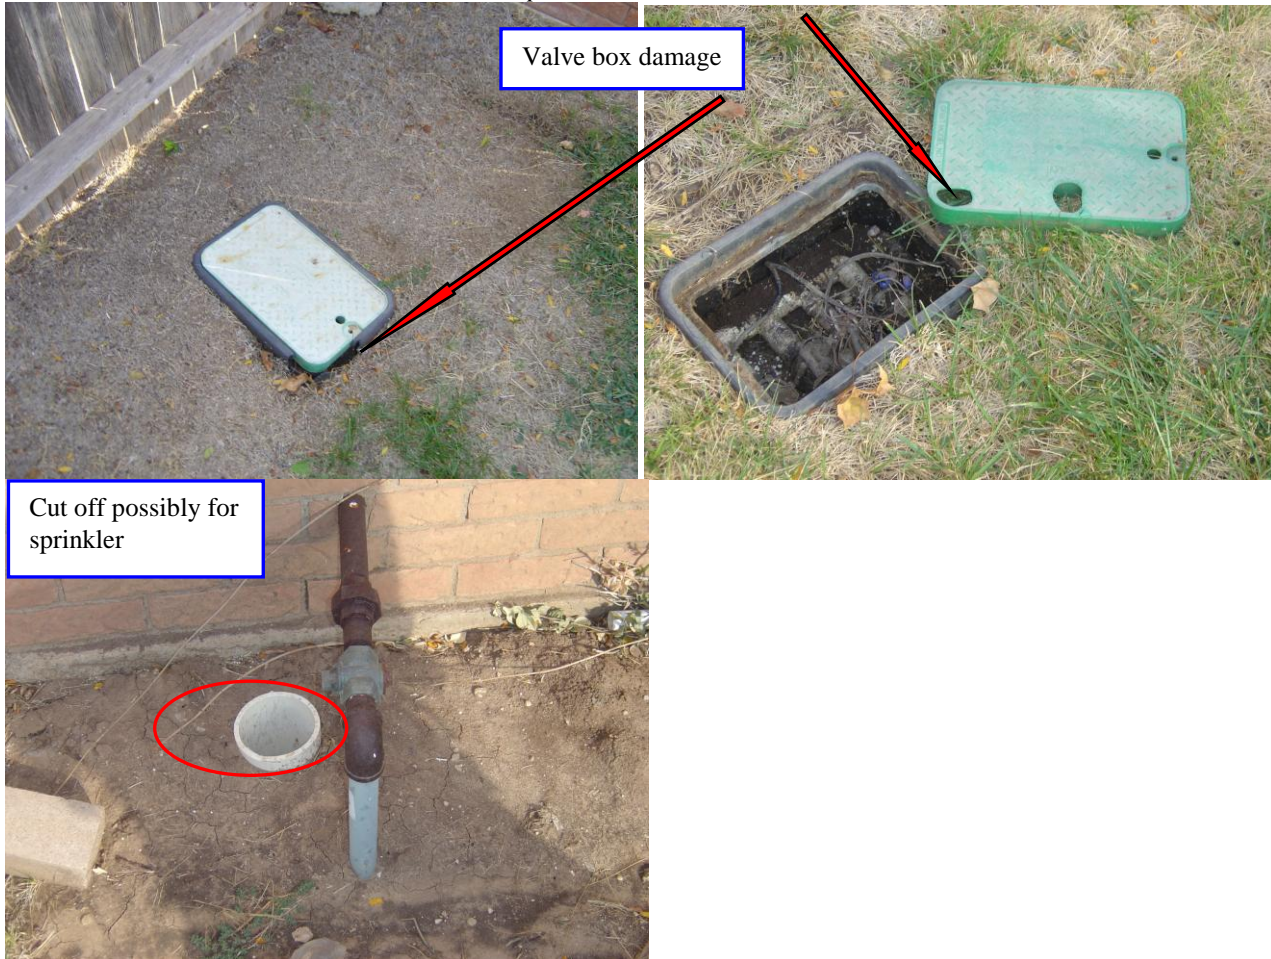
- *The sprinkler valve boxes (on the east side and in the back yard) have damage to the housing or the cover. The valves are shallow and are not insulated. They should be considered for winter possible insulation.*
- *There is a manual cut-off valve in the back by the gas cut off valve that was not inspected but the owners should be asked?*

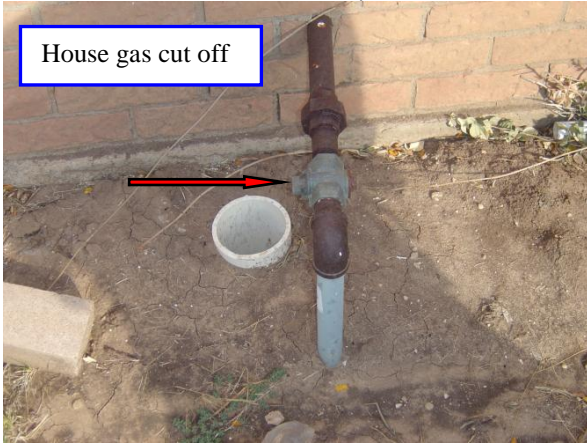
- E. Gas Supply Systems** *Comments: The meter is in the alley and the house cut off is at the back yard area by the condenser.*
